Reference: Report of Geotechnical Engineering Services  
Bellerive at Fox Hollow  
9126, 9138, and 9150 Callaway Drive  
Trinity, Pasco County, Florida  
Anticus Project No: 01.6141.23

As authorized, we completed a Privacy Wall Evaluation which included a ground penetrating radar (GPR) survey, two (2) hand auger borings in conjunction with static cone penetrometer (SCP) testing, damage assessment, and foundation test pit. The field testing was completed along the area of settlement / cracking of the CMU block privacy wall located along the rear (north) perimeter of 9126, 9138, and 9150 Callaway Drive, Trinity, Pasco County, Florida. The following report briefly describes the field test procedures used and presents the findings and conclusions.

Privacy Wall Evaluation  
Bellerive at Fox Hollow  
Callaway Drive  
Trinity, FL

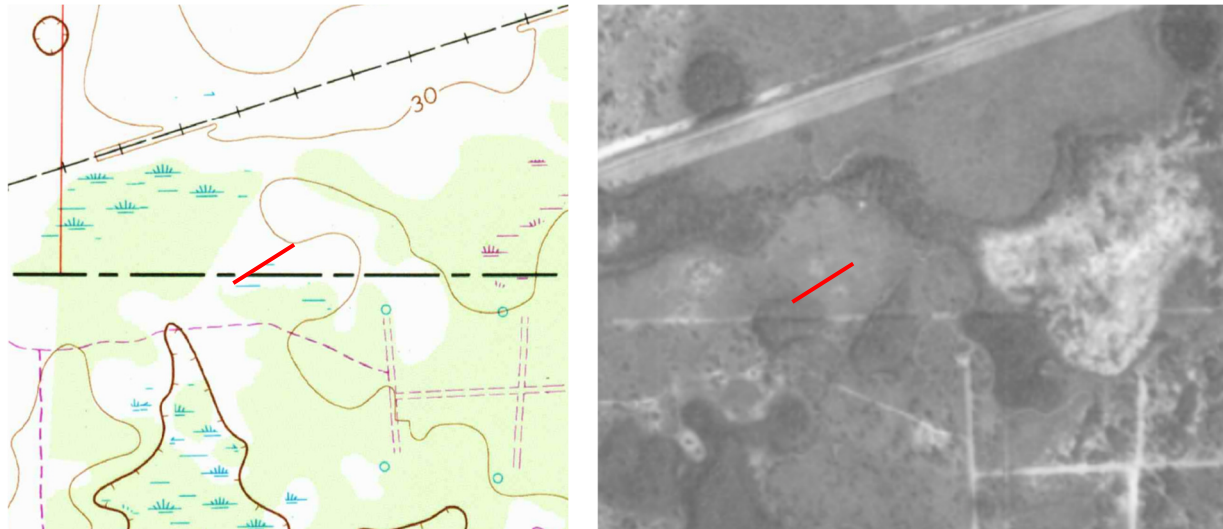
**Figure 1:** View of 1970 historic aerial and 1974 historic topographic map of the subject property. The red line indicates the approximate current location of the privacy wall.

Based on review of historic aerials and topographic maps, the privacy wall is located within a former marsh area. Organic-laden soils are prevalent in marshes. Organic-laden soils are considered deleterious due to the propensity of organics to decay, which results in a reduction in the volume of the material and subsequent settlement of overburden soils and the structure(s) which they support. Peat and/or organic-laden soils were recovered within the hand auger borings, HA-1 and HA-2, performed along the privacy wall. Organic soils above the groundwater level decay at a faster rate than organic soils below the water table due to continued exposure to oxygenated storm water filtering through the soils from above. The organic soils recovered within the hand auger borings were encountered above the groundwater level. The distress is consistent with the effects of differential foundation settlement caused by a reduction of soil support due to the decay of organic material.

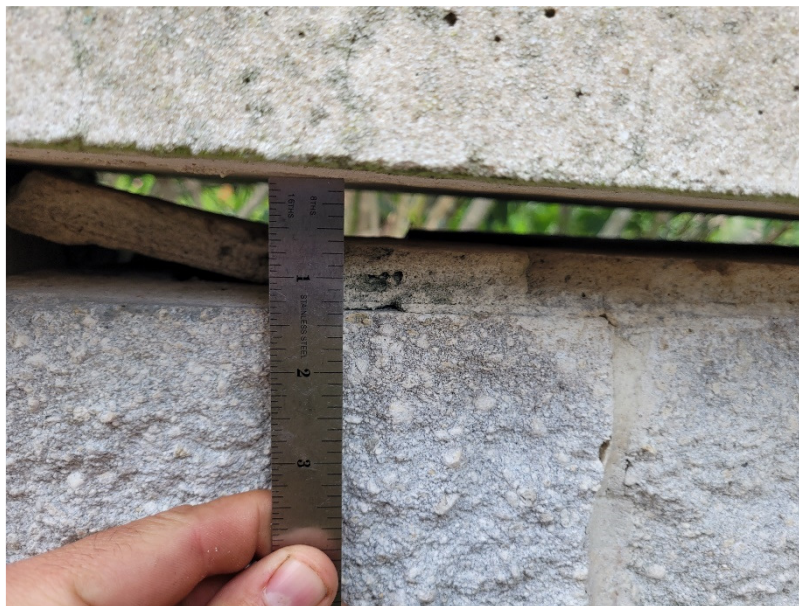
In the area of concern, separations and stair-step cracks up to approximately an inch wide were observed in the privacy wall. A portion of the cracks exhibited horizontal offset. In the section of the privacy wall behind 9126 Callaway Drive, a portion of the cracks on the privacy wall were observed to have been previously repaired and since then have re-opened. In addition, the section of privacy wall behind 9126 Callaway Drive was observed to be out of plumb or leaning towards the north. Below in **Figure 2**, is an image of a 1/2 wide crack / separation between the top cap and CMU block in the privacy wall.

**Figure 2:** View of crack / separation in the privacy wall.

Although the organic soils are the primary cause of distress, the lack of filled cells and presence of animal burrows likely exacerbated the observed conditions. Within the GPR survey, minimal cells were imaged to have been filled during construction of the wall. The purpose of cell fill is to strengthen the wall structure which aides in the wall ability to resist loads or differential movement. The cells were not filled to current industry standards. The presence of animal burrows may have also contributed to the distress. Gopher Tortoises are known to excavate relatively deep burrows. The burrow creates void space in the subsurface and over time the holes collapse, causing settlement of overburden soils and the structure(s) which they support.

In order to stabilize the shallow organic laden soils supported the existing privacy wall, we would recommend a limited chemical grouting program. Chemical grouting would densify the existing shallow soils and encapsulate the existing organ laden soils to reduce the future risk of settlement / consolidation of the privacy wall. Another benefit to the chemical grouting program would be to fill in any void spaces caused by the observed abandoned animal burrows. Injection is completed through temporary grout pipe (generally less than 1/2 inch in diameter) drilled into the ground with a sacrificial tip at the pipe end. The chemical grouting will utilize a two part chemical injected at a given depth, the two chemicals react fairly instantaneously, expanding and mixing with the soil, filling voids, and consolidating very loose and very soft areas and encapsulate the organic laden soils – generally chemical grout will improve the densities of the subsurface soils to medium dense. We recommend 20 chemical grout injection locations (at approximate 5 foot center to center spacing), with injections at 3 feet and 5 feet as illustrated on the attached plan. We recommend that each grout point be injected with approximately 25 pounds of chemical grout (we recommend 486 STAR or engineer approved equivalent). The estimated cost for the chemical grout program, including engineering observation is approximately \$9,900.00.

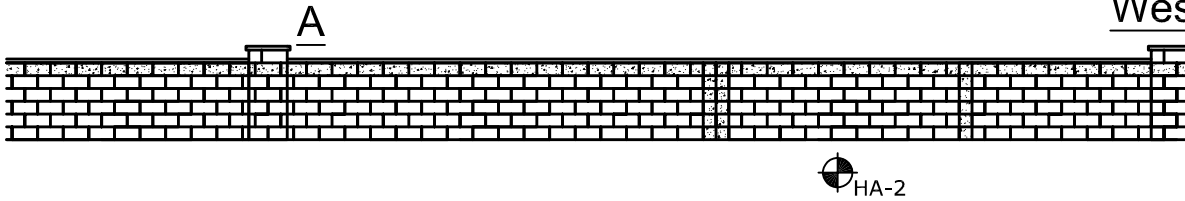
PRIVACY WALL CELL FILL & FIELD TEST LOCATION PLAN

The GPR survey was performed along an approximately ninety-four (94) foot section of the privacy wall along the rear (south) perimeter of the properties located at 9126, 9138, and 9150 Callaway Drive. The results of the GPR survey indicate that a minimal amount of the CMU block cells were filled with grout or similar material. The location filled CMU cells can be viewed in the attached Privacy Wall Cell Fill and Field Test Location Plan, Sheet 1.

The test pit excavation of the foundation indicated an approximately 12 inch thick cast-in-place concrete footing with an approximate 3 inch offset from the CMU block stemwall (indicating an approximate foundation width of 14 inches), that was embedded approximately 12 inches in depth. The location of the test pit is presented in the Privacy Wall Cell Fill and Field Test Location Plan, Sheet 1.

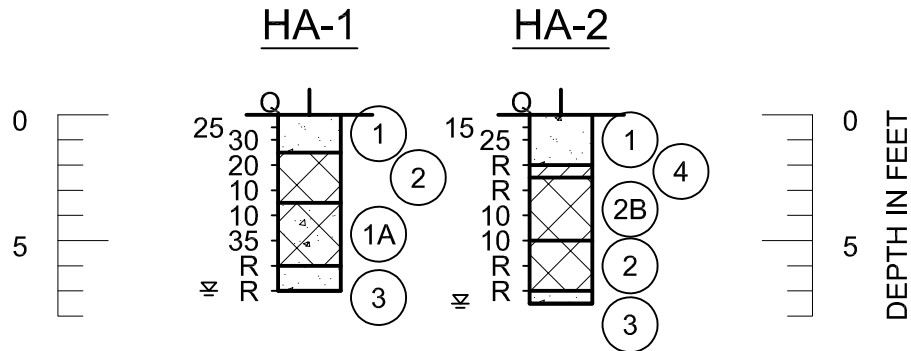
# SOIL PROFILE

Two (2) hand auger borings were performed at the locations shown on the attached Field Test Location Plan. The hand auger borings encountered loose to medium dense SAND to SAND With Silt (SP/SP-SM) to approximate depths of 1.5 to 2.5 feet. The surficial sands were underlain with very loose and medium dense PEAT to Silty SAND (SM) or organic-laden soils, underlain by medium dense SAND with Clay (SP-SC).
